## Utah Geological Survey

Project: September 12, 2002, fire-related debris flows east of Santaquin and Spring Lake, Utah County, Utah			Requesting Agency: Santaquin City
By: Greg N. McDonald Richard E. Giraud	Date: 11-20-02	County: Utah	Job No: 02-09
USGS Quadrangle: Payson Lakes (965) Spanish Fork (1006) Springville (966) West Mountain (1007)		Section/Township/Range: Sections 31 and 32, T. 9 S., R. 2 E.; Sections 6 and 7, T. 10 S., R. 2 E.

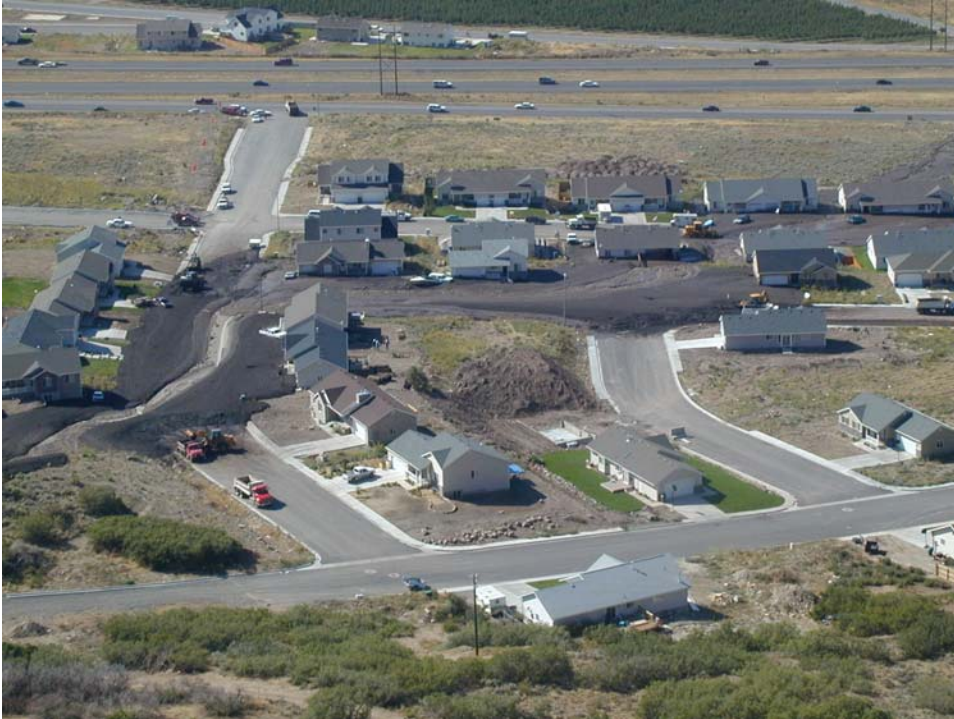
(a) View looking west of tributary 4 north deposit in Santaquin subdivision. Photo by Dale Deiter, U.S. Forest Service.

The debris flow from tributary 4 was the most damaging of the five. When the flow reached the mouth of tributary 4, it split into two lobes. The larger, north lobe flowed through the Santaquin subdivision causing substantial property damage (figure 4a, figure 5). Most of the north lobe did not follow city streets but established a direct path down the alluvial fan. Subsequent floodwater traveled down roadways. The south lobe flowed down an undeveloped portion of the fan and deposited debris on a newly excavated subdivision road south of the existing development.

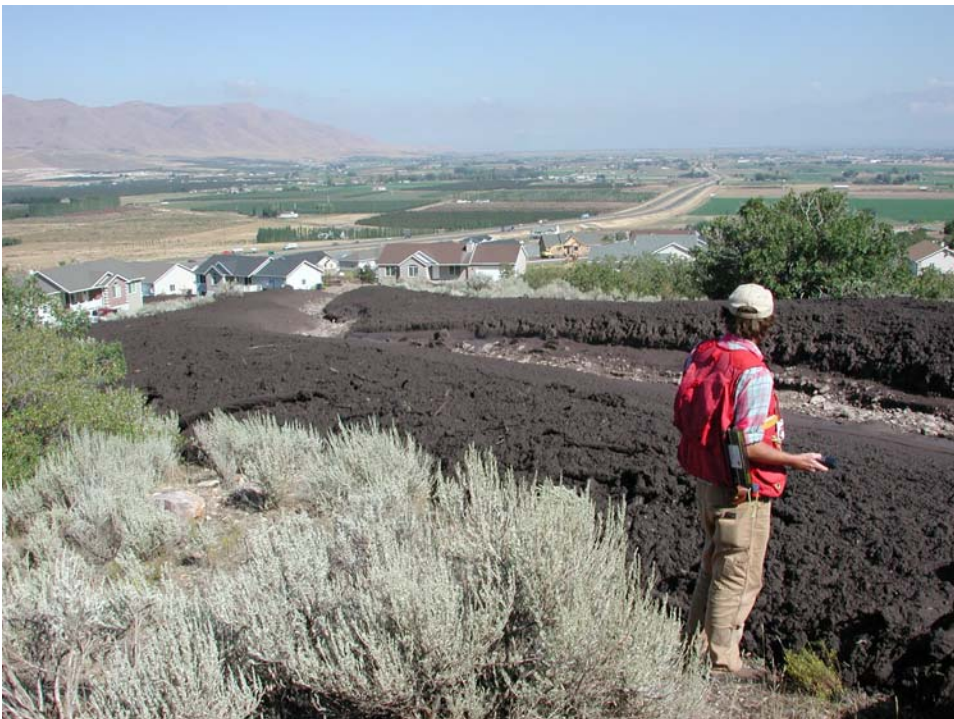
(b) Levee deposits of tributary 4 north lobe on the fan apex.

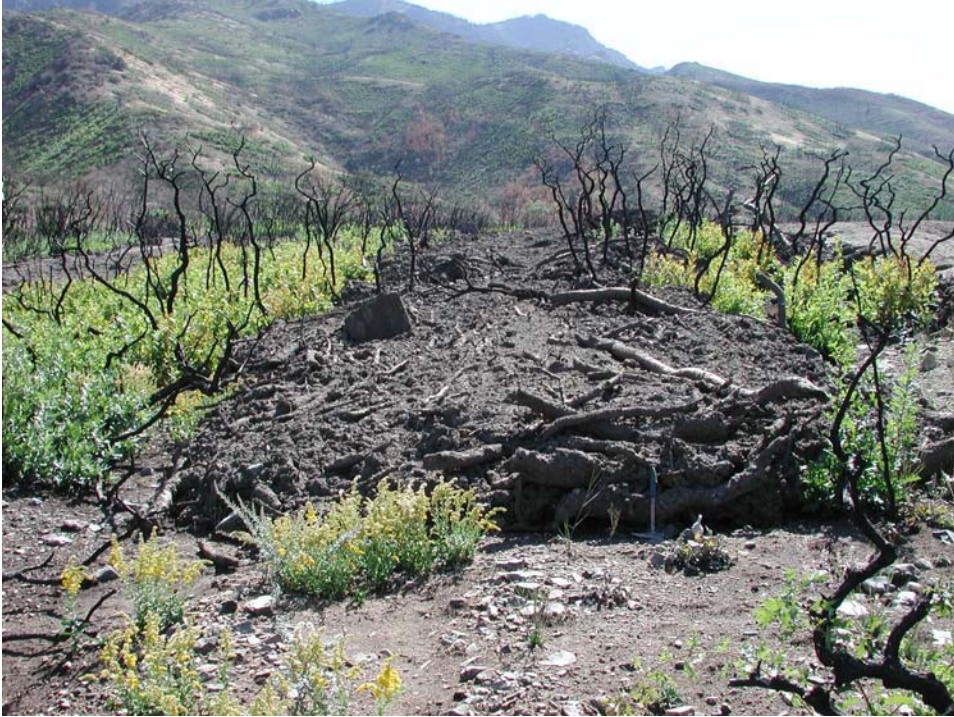
(c) Toe of tributary 5 overbank deposit north of main lobe.

The debris flow from tributary 5 deposited sediment at the mouth of the drainage east of developed areas. Post debris-flow floodwater reached a subdivision, including a newly excavated road; however, no major property damage was reported. The debris-flow deposit on the upper portion of the fan contained considerable woody debris and trees up to several inches in diameter (figure 4c). Near the top of the deposit a moderate-sized lobe is present north of the main flow that contains much less woody debris and large clasts, and likely represents a later surge.

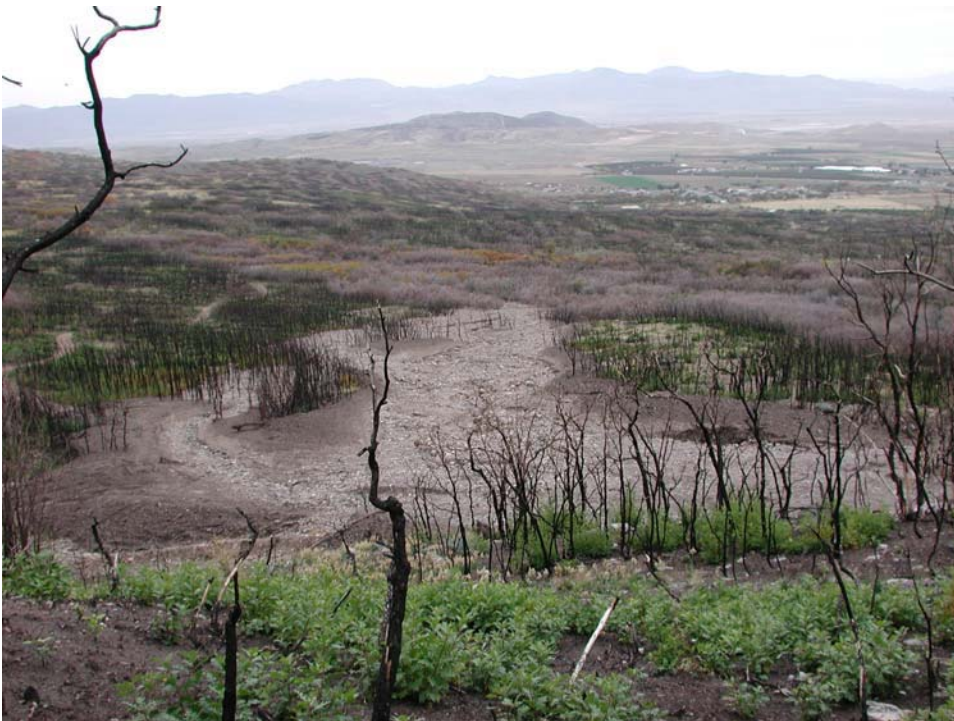
(d) View of tributary 6 deposit looking downfan (eastward).

The tributary 6 deposit was similar in character to the tributary 5 deposit. Neither the debris flow nor associated floodwater affected any developed areas (figure 4d).

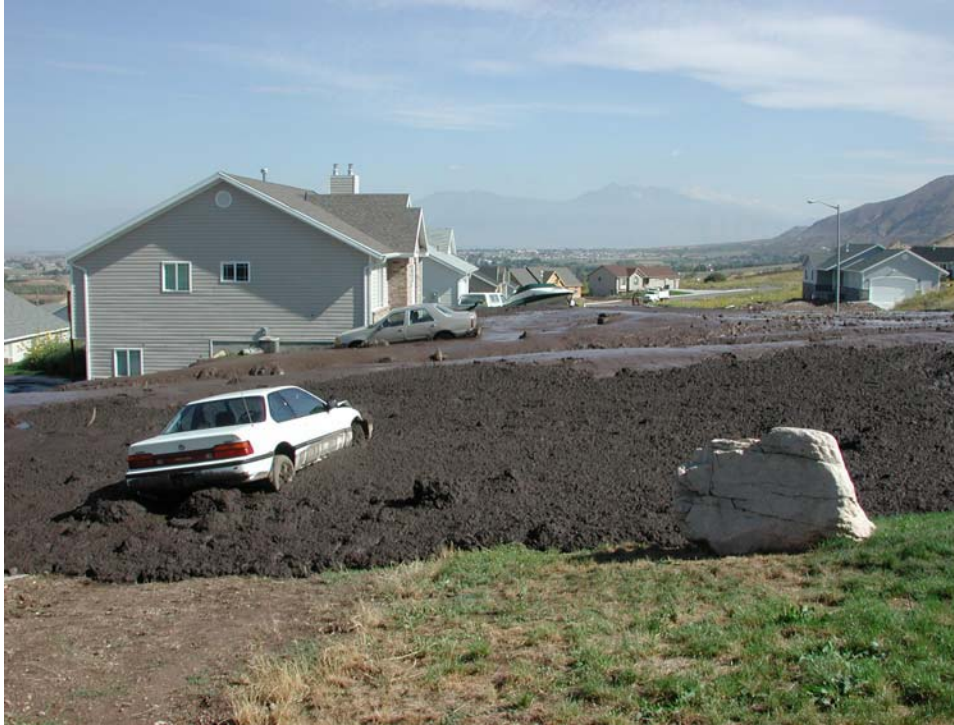
(a) Debris-flow sediment deposited at the intersection of Lambert Avenue and Apple View Street. The debris flow rafted vehicles and filled basements with sediment.

Three of the five debris flows and associated flooding caused damage to infrastructure, property, and houses in the communities of Santaquin and Spring Lake. Most of the damage occurred at the Santaquin subdivision from the north lobe of the tributary 4 debris flow. Vehicles were moved (figure 5a), some were pushed into houses; basements were flooded and filled with debris as ground-level windows were broken (figure 5b); house and garage doors were buckled inward (figure 5c); and the back wall of one house was broken by impact forces (figure 5d). A preliminary report prepared by Ryan Pietramali of the Utah Division of Emergency Services indicates five homes and two businesses received major damage and 27 homes received minor damage at a total cost of about \$500,000 (U.S. Small Business Administration Damage Assessment Report dated September 19, 2002).

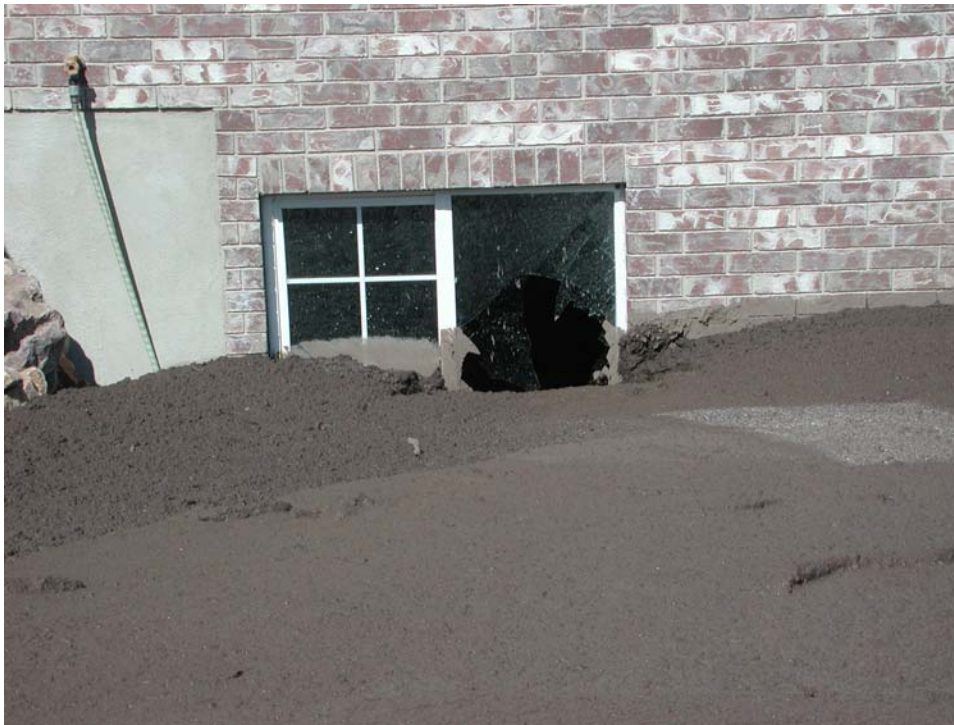
(b) The debris-flow impact broke through this basement window of a house on Apple View Street.

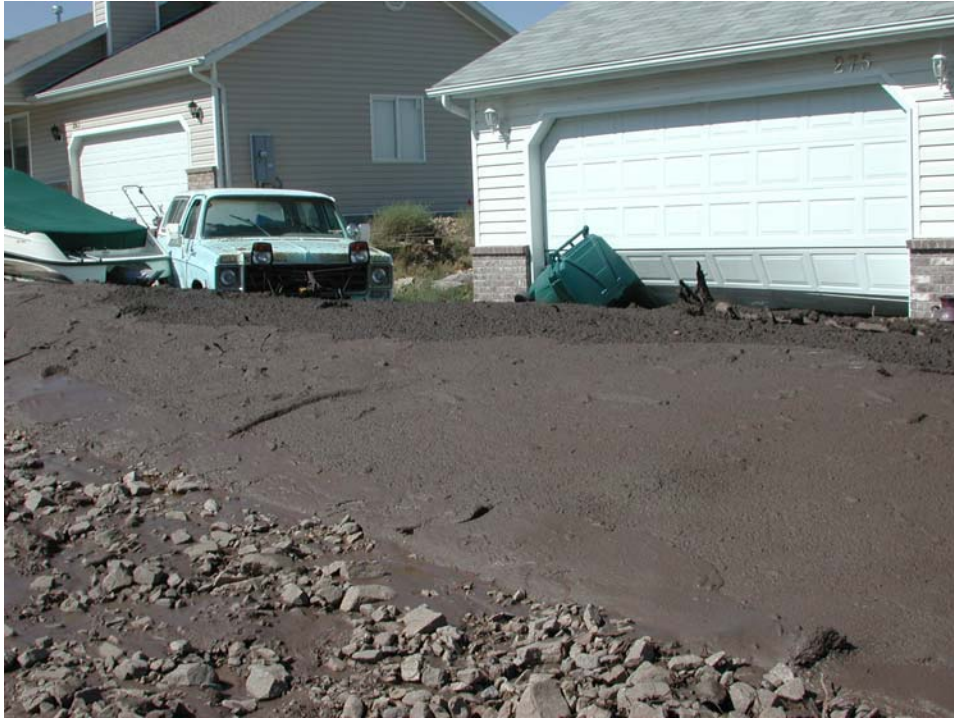
(c) Debris-flow damage to garage doors of house on Peach Street.

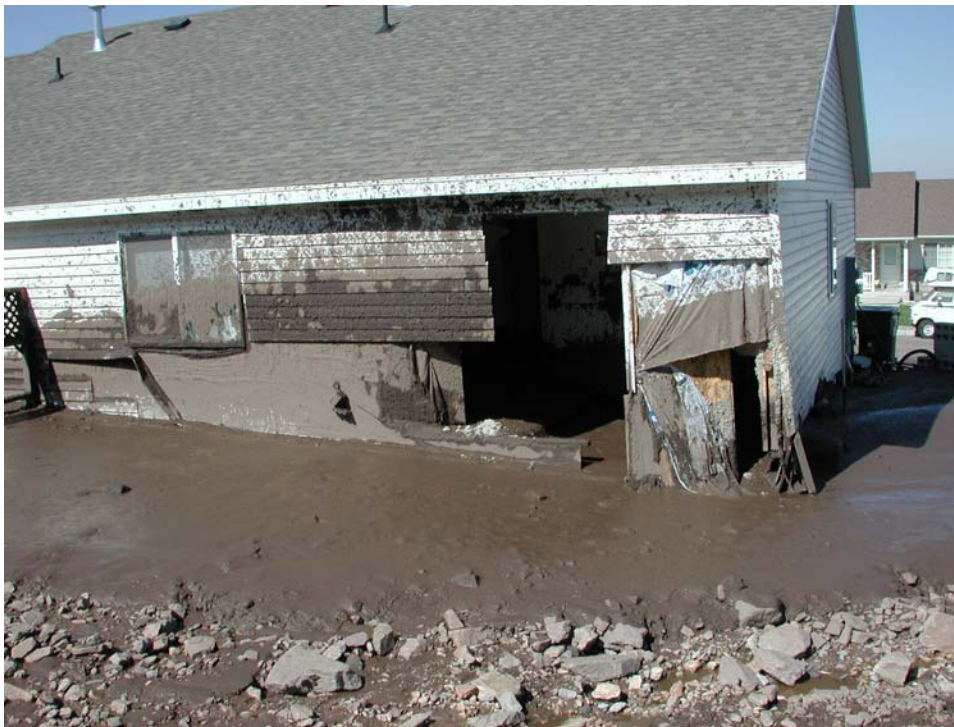
(d) Debris-flow damage to the back wall of house on Peach Street.
